Manhole Inspection Summary

Manhole # S51C__034MH

Insp Date: **2/3/09 1:20 PM**

Location Address: **1 N LINWOOD-CURLEY-ALLEY**

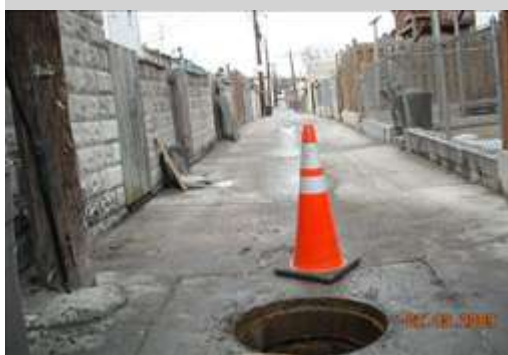
Location View

Manhole Type: **Terminal** Location: **Alley** Ground Conditions: **Standing Water**

☐ Prev. Rehab Weather: **Snow** Subject To Ponding: **Ponding**

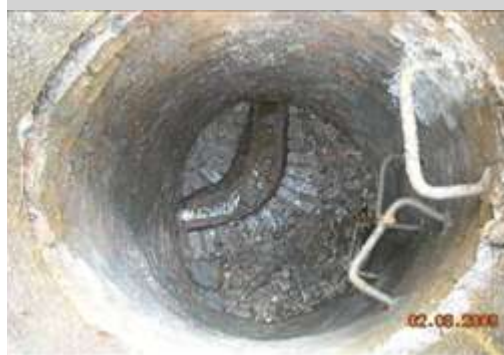
Top View

Comments **BROKE AND REPLACED COVER (see photos)**

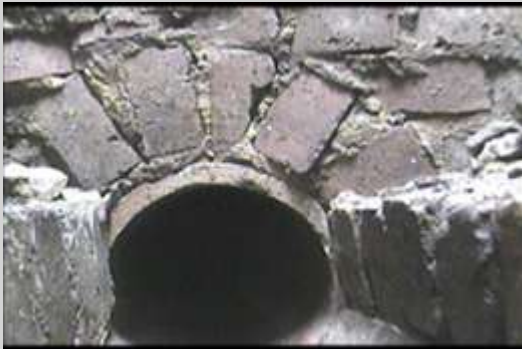
12 O'Clock Outflow

Pipe Height: **8.4** (in.) Rod and Bar (Angled)
Pipe Material: **Clay** ☐ Pipe Lined
Invert Depth: **7.68** (ft.) Flow Characteristics: **Slow**
Deposits: ☒ None ☐ Mud ☐ Sludge ☐ Debris ☐ Grease
Silt Depth: **0** (in.) Deposits Extent:
Infiltration: **None** Pipe Seal Cond: **Sound**
